Manhole Inspection Summary

Manhole # S45KK_054MH

Insp Date: **3/1/10 1:01 PM**

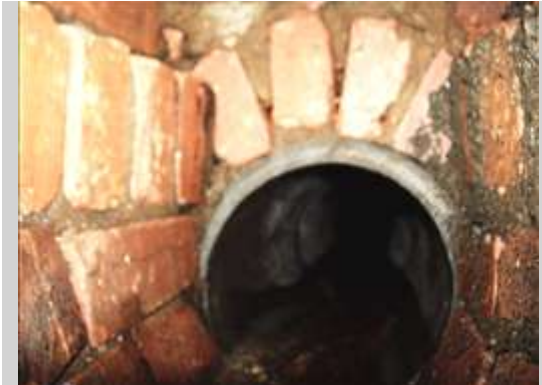
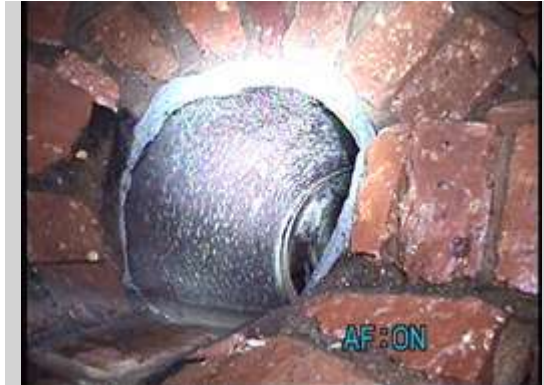
8 in. Circular Gravity Sewer
Pipe Out @ 12 O'Clock

Pipe Height: **12** (in.) Rod and Bar (Angled)
Pipe Material: **Clay** ☐ Pipe Lined
Invert Depth: **9.42** (ft.) Flow Characteristics: **Fast**
Deposits: ☒ None ☐ Mud ☐ Sludge ☐ Debris ☐ Grease
Silt Depth: (in.) Deposits Extent:
Infiltration: **None** Pipe Seal Cond: **Sound**

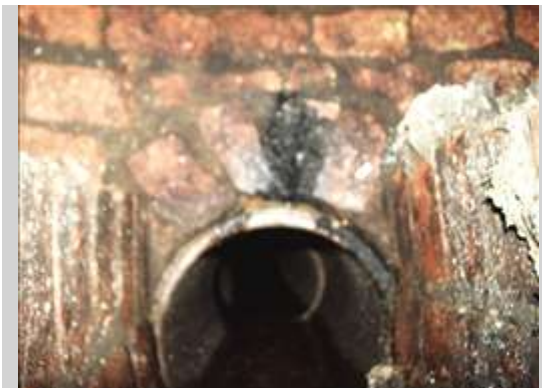
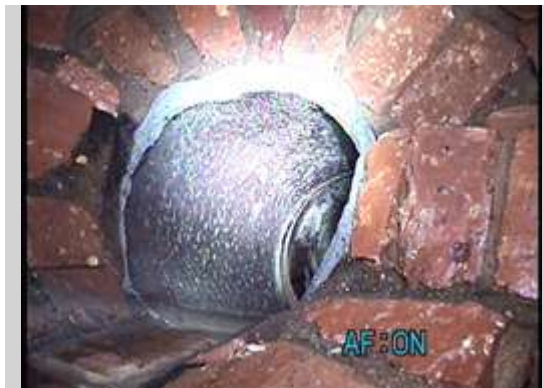
8 in. Circular Gravity Sewer
Pipe Out @ 3 O'Clock

Pipe Height: **12** (in.) Rod and Bar (Angled)
Pipe Material: **Clay** ☐ Pipe Lined
Invert Depth: **9.00** (ft.) Flow Characteristics: **Fast**
Deposits: ☒ None ☐ Mud ☐ Sludge ☐ Debris ☐ Grease
Silt Depth: (in.) Deposits Extent:
Infiltration: **None** Pipe Seal Cond: **Sound**

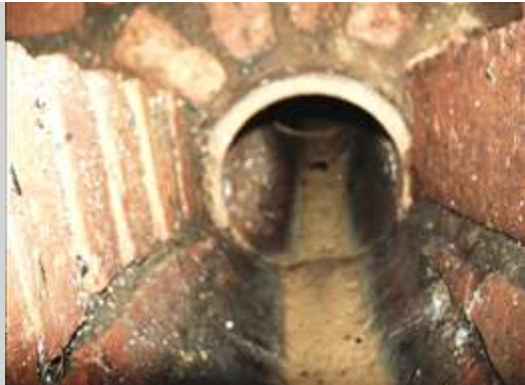
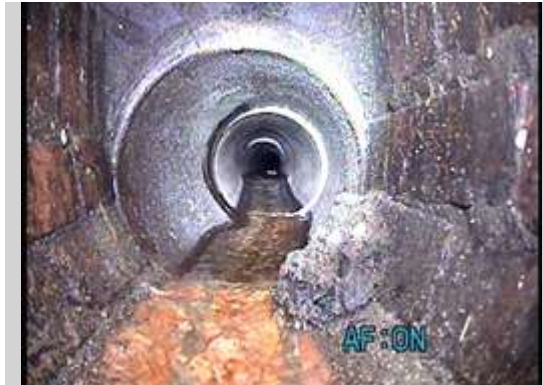
Pipe In @ 6 O'Clock

Pipe Height: **8.4** (in.) Rod and Bar (Angled)

Infiltration: **None** Pipe Seal Cond: **Sound**
